Mt. Agamenticus Parking and Traffic Flow Needs Study

Prepared by Southern Maine Planning and Development Commission for
The Town of York Parks and Recreation Department

November 7, 2016

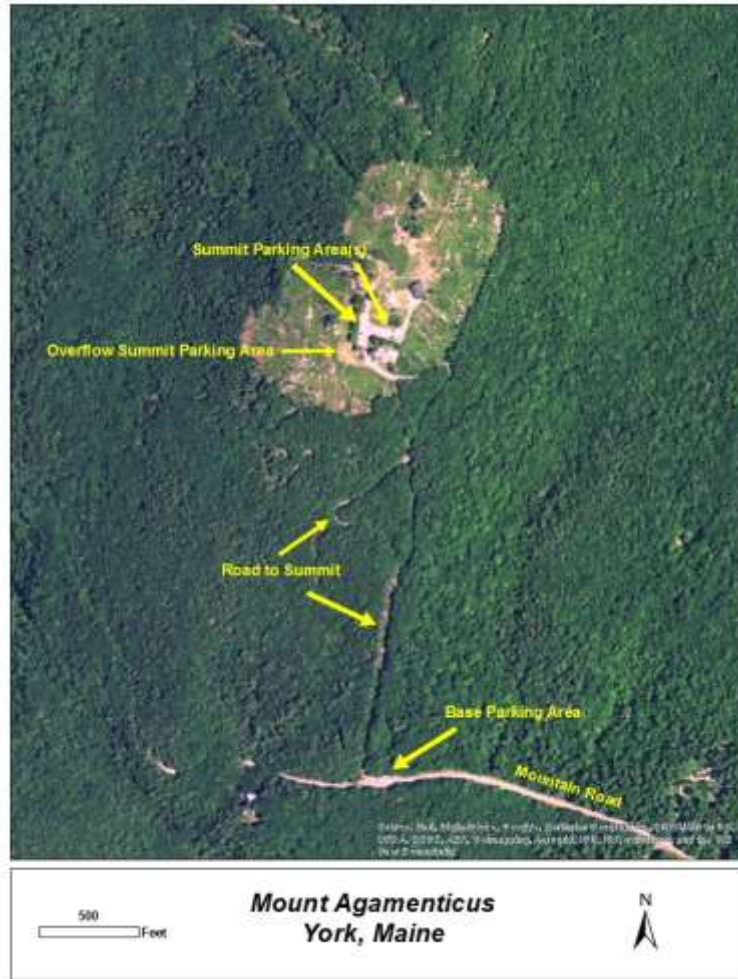
Figure 1 – Overview of Mt. Agamenticus Parking Areas

The main parking areas are depicted on Figure 1.

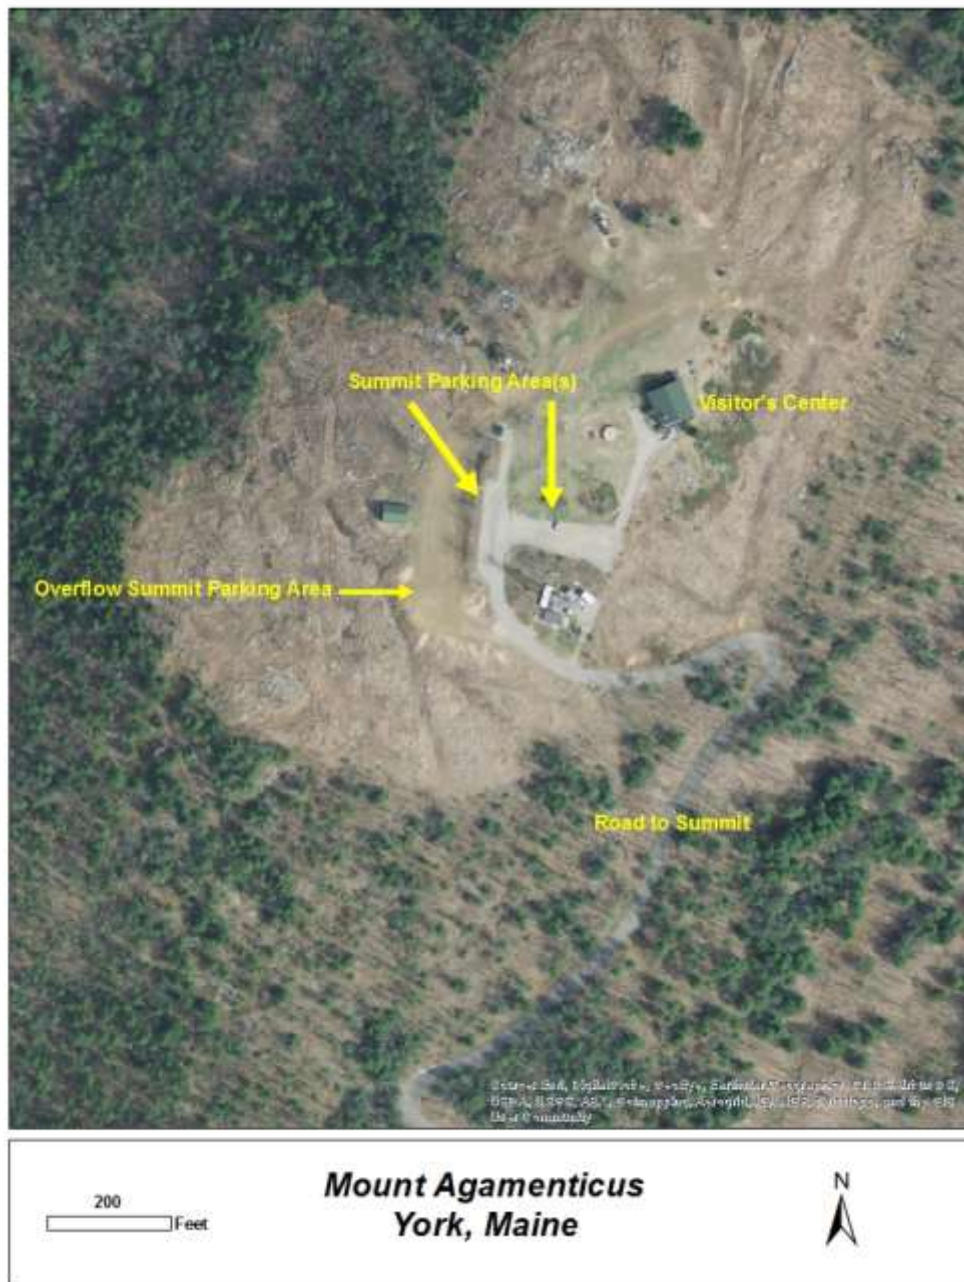
Figure 2 – Summit Parking Areas

The summit has the largest area available for public parking at the mountain, with approximately 36 spaces. It is separated into 2 general locations (see Figure 2).

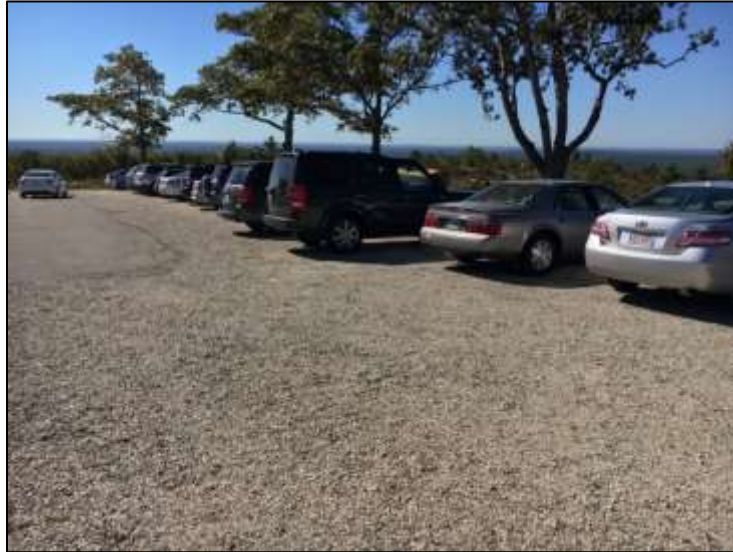
Summit Parking Area – West Side

One location at the summit has approximately 12 spaces and is located near the west side of the access road. It is bordered by a split-rail fence, and drivers typically park “head-in” along the fence facing west. The rough dimensions of the available parking area here is 152 by 26 feet.

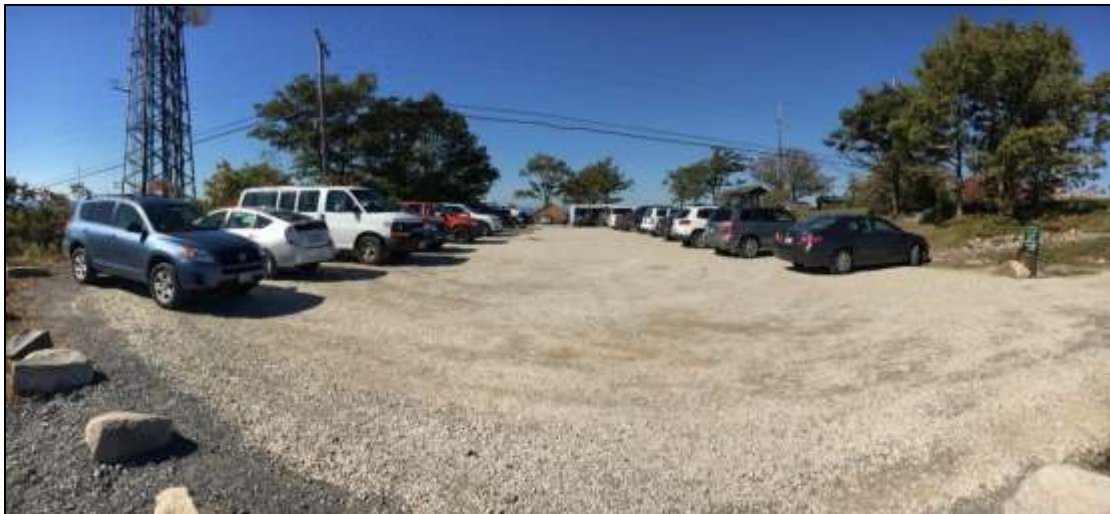
Main Summit Parking Area

The main parking section has approximately 24 spaces and is adjacent to the information kiosk and walk ways to the summit building. Drivers usually form two long rows on both the north and south sides of the parking area (about 12 spaces in each row). The area measures approximately 187 by 47 feet. The two parking areas are separated by a travel way that is approximately 16 feet wide.

There are no designated handicapped parking spaces at the summit.

- Consider widening the main summit parking area to better accommodate two full rows of head-in parking. The current size of the area does not meet the usual dimensions that are desired for this type of parking.

- Pave and stripe the two primary parking areas, including pedestrian crossings at appropriate locations. This would essentially increase the number of spaces available and improve the parking efficiency of visitors. Alternatively, consider designating and paving only handicapped parking spaces.

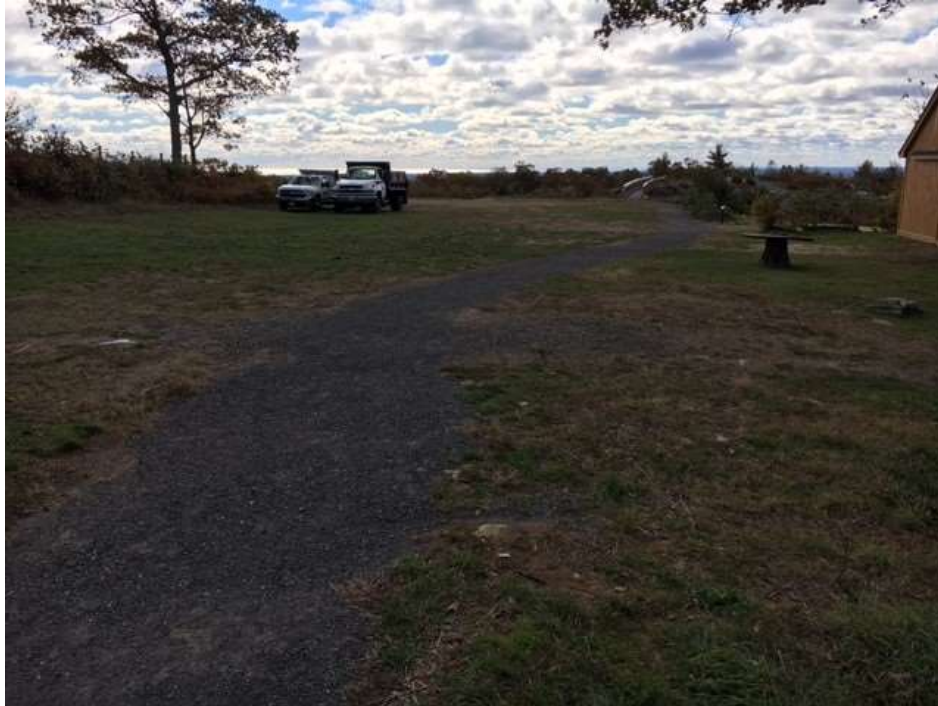
Overflow Parking Area

There is also an overflow parking area near the small barn on the west side of the summit, which staff opens if parking in the other two areas becomes full. This area is also used for bus parking when needed. The area is usually blocked off with a cable, and there is a sign located at the entrance which reads “No Parking, Overflow Only”. The size of the overflow parking area is approximately 300 by 66 feet.

- Change language of sign at the entrance to the overflow lot. Currently, the sign reads “No Parking. Overflow Only”, which could be confusing to drivers even if the cable across the entrance is removed. It could simply say “Additional Parking”, since they would not be able to otherwise enter the lot if it is closed by staff.

- Consider opening the overflow parking area for longer periods of time. Paired with changing the sign here to “Additional Parking”, this would provide visitors with additional parking options and essentially double the possible spaces available in the short term.

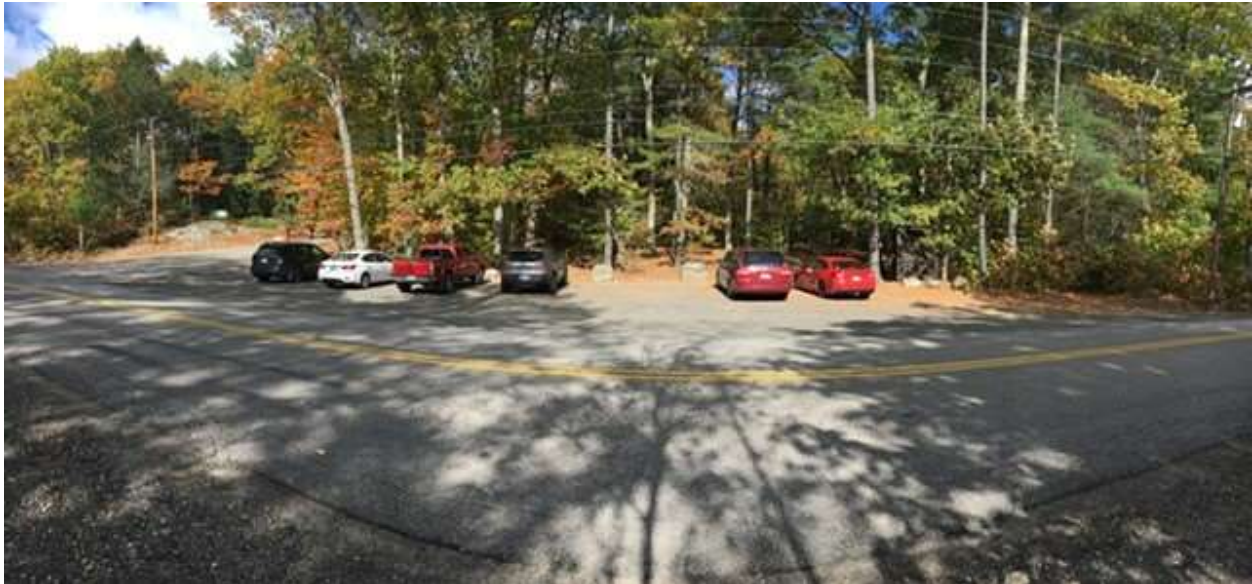
The base parking area is located to the right (east) of the summit access road, and has room for approximately 10-12 vehicles. There is no designated handicapped-accessible parking at the base parking area.

- The primary recommendation is to find a way to expand the amount of parking available at or near the entrance. The current area is very small, and does not provide safe or adequate accommodations for larger vehicles or school buses.
 - Based on data, video and information from Mt. Agamenticus Staff, the area should be large enough to accommodate an additional 75 vehicles.
 - The area should also provide separate/striped parking for at least 4 full-size school buses, along with adequate space for loading and unloading students and enough room for buses to turn around safely within the parking area.

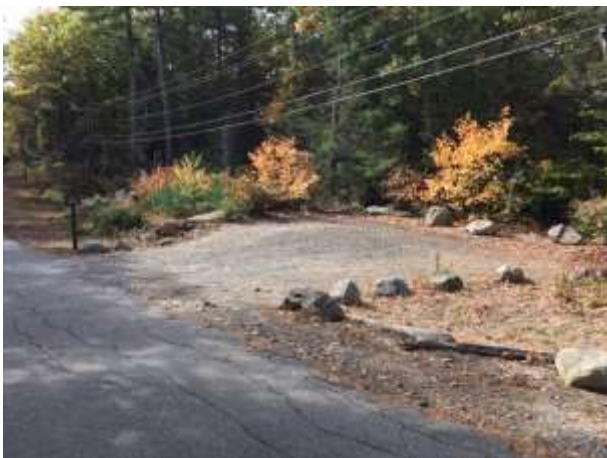
Small Area at Ring Trail Crossing

There are also two small parking areas along the summit access road. One is located where the Ring Trail crosses the road on the west side, and can accommodate about 3 vehicles. The other is located further up the summit road on the east side, where there is additional access to the Ring Trail. This area is slightly larger, but still can only accommodate 5 or 6 vehicles.

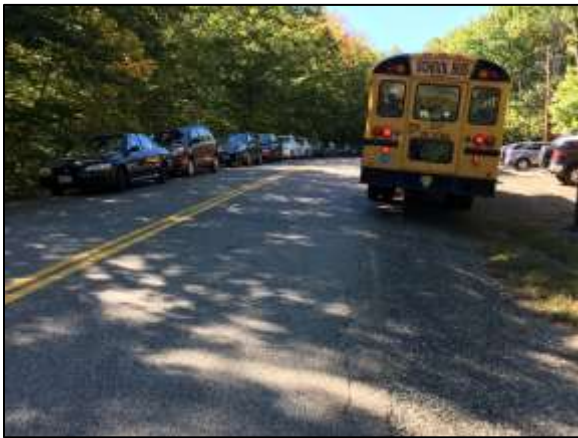
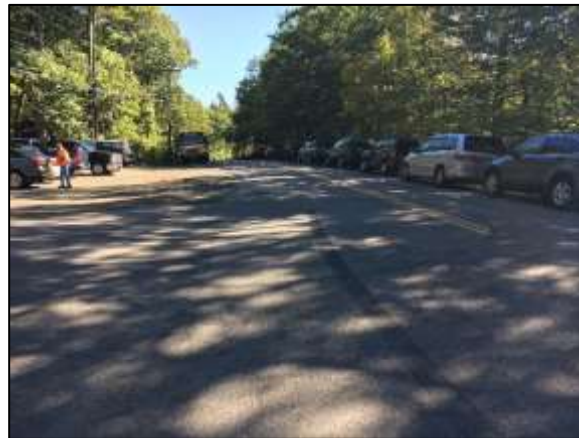
Parking along Mountain Road

Although not sanctioned or promoted by Mount Agamenticus, visitors frequently parallel park on both sides of Mountain road – both east and west of the summit access road. This is particularly the case on busy weekend days and holidays, and also on weekdays when there are a large number of school groups visiting the mountain. Drivers attempt to get as far off the pavement as possible, but they do encroach onto both travel lanes of Mountain Road. It is common for Mt. Agamenticus Staff and the patrol officer to count up to 30 vehicles along the road. On busy weekends, this number is typically between 50 and 60 vehicles. There are no signs prohibiting parking on Mountain Road.

- Pave and stripe the parking area. This would essentially increase the number of spaces available and the parking efficiency of visitors.
- Work to accommodate handicapped parking and accessibility in future parking improvements or changes.
- Once a new parking area has been established, install “No Parking” signs along Mountain Road.

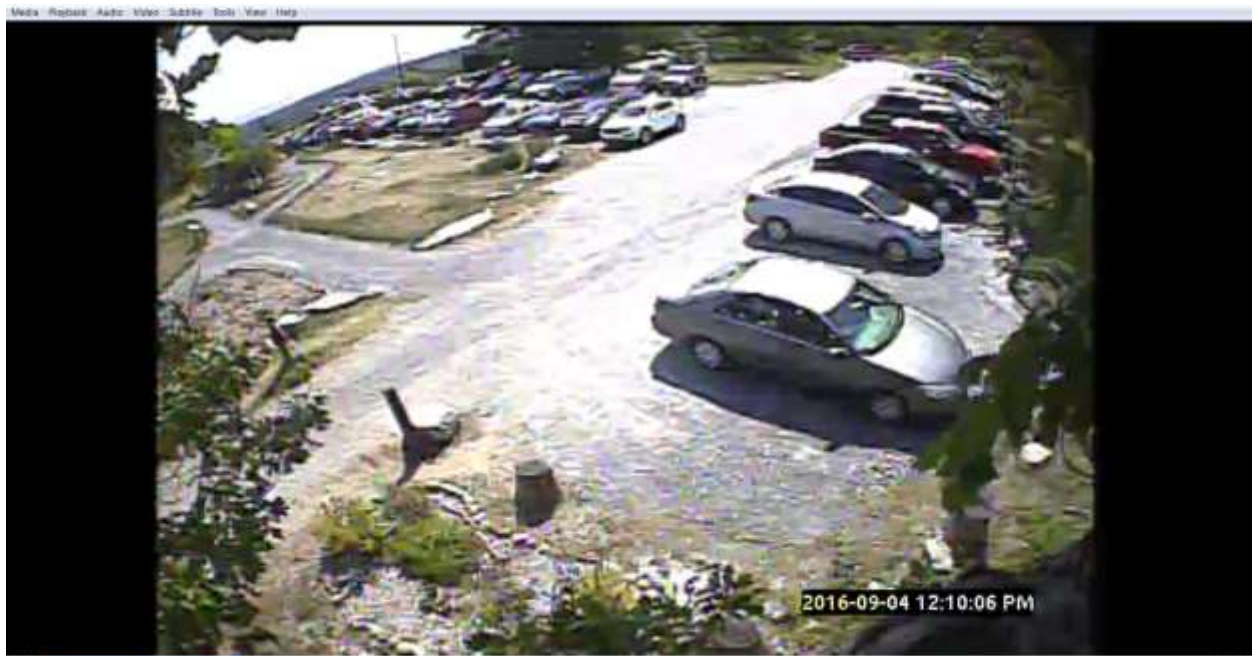
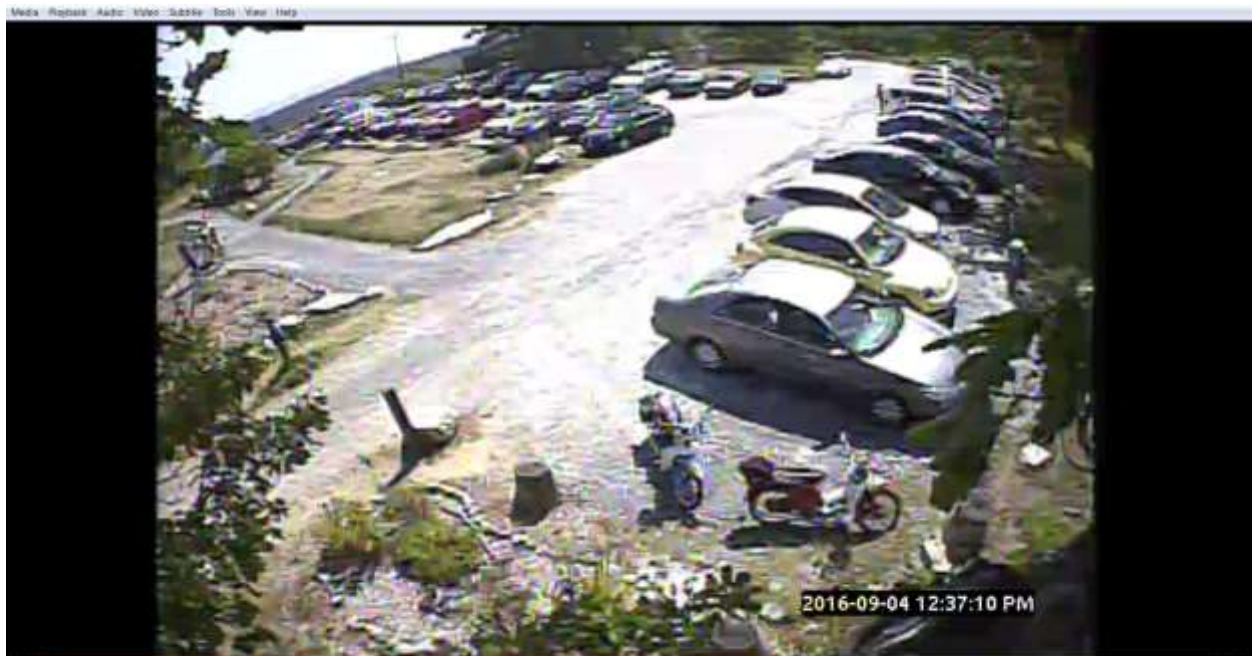
Generally speaking, most drivers tend to park in the appropriate areas at the summit lot. In the larger parking area, people usually form two rows of parking as depicted in the following two photos.

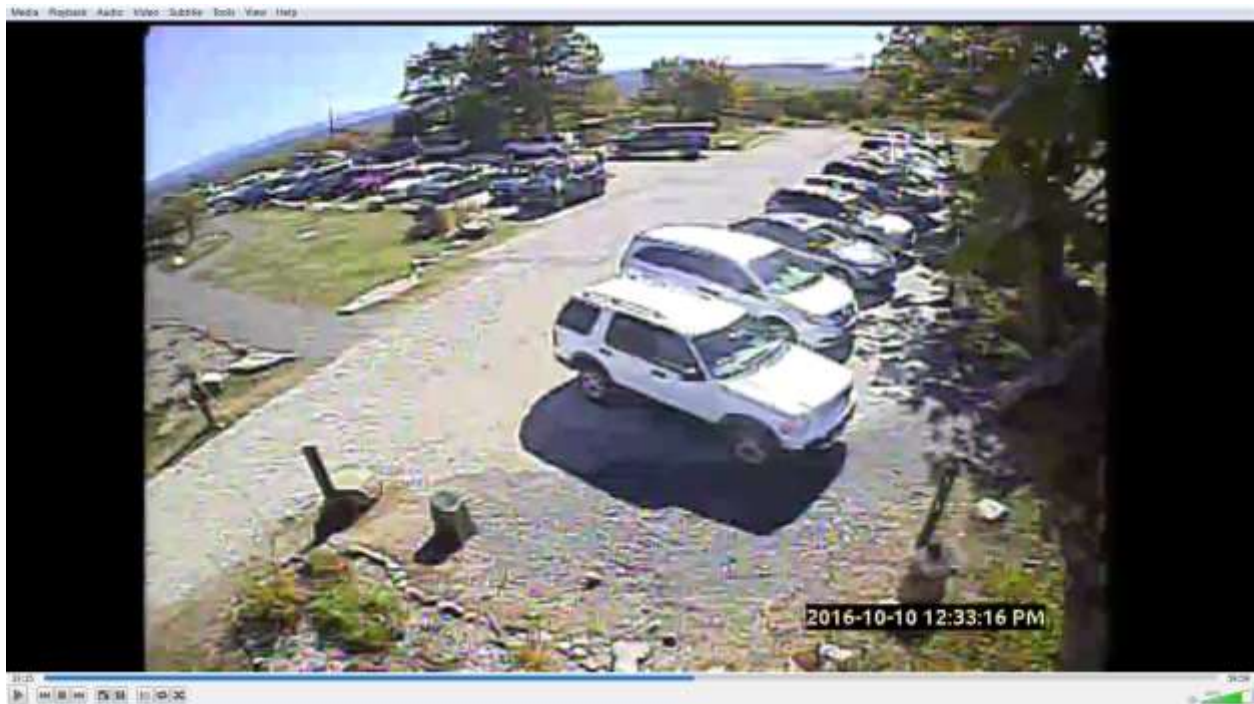
However, the width for the largest section of the lot is technically not wide enough for two rows of head-in parking. This causes people in some cases to parallel park on the right side of the parking area, instead of making another row of head-in parking (see the following photos). This results in a lower number of spaces being available, since only about 4 or 5 vehicles can park on the right side of the lot.

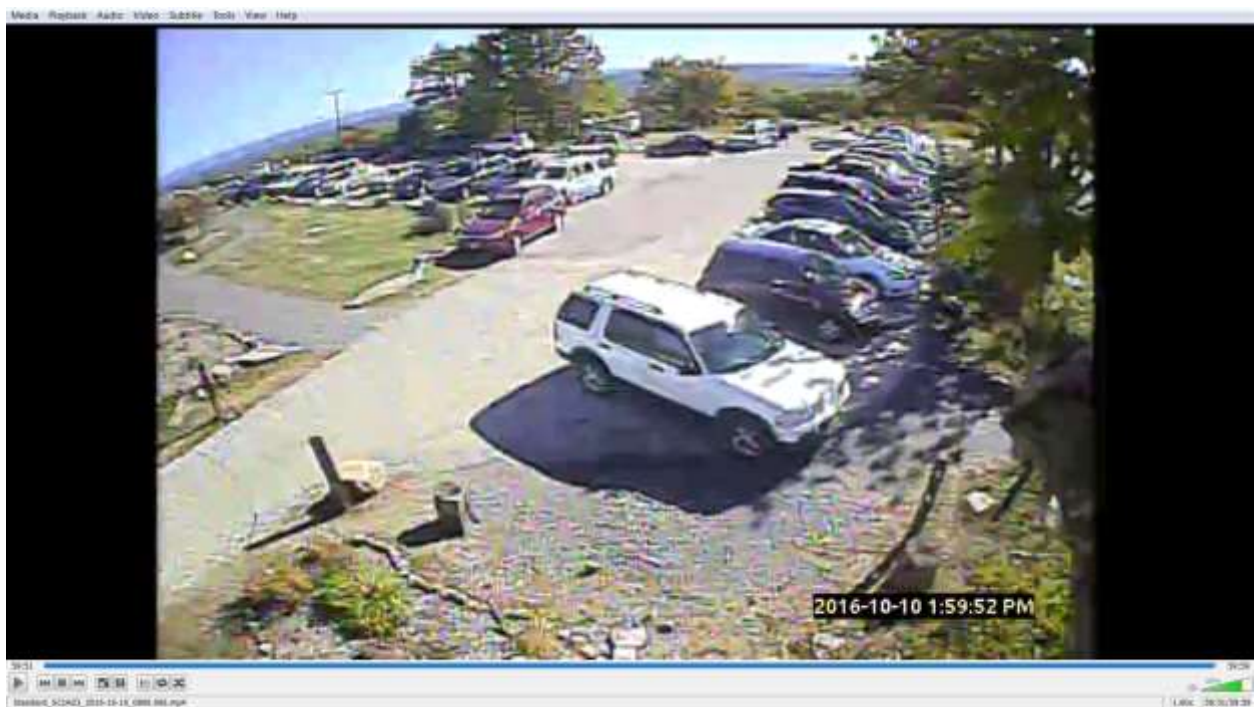
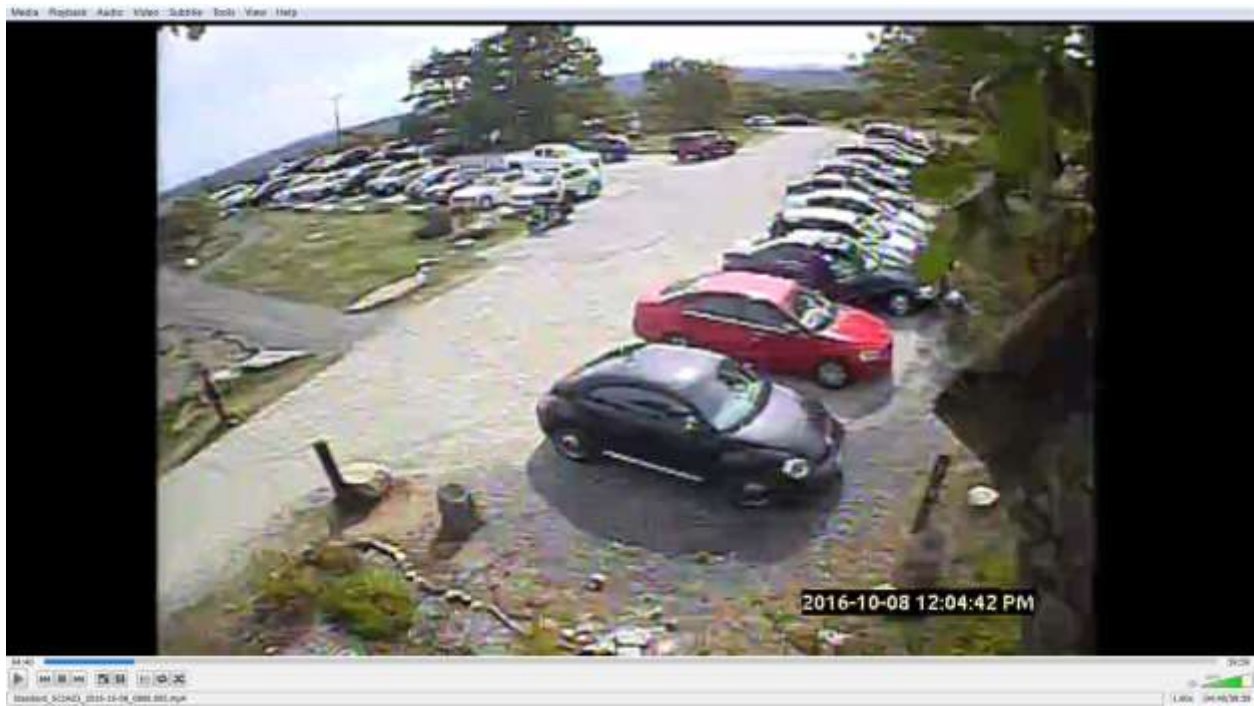
The parallel parking also results in people parking along the side at the top of the access road as seen in the following two photos:

- Provide adequate space for at least 2 full-size school buses at the summit.
- Install “No Parking” signs along both sides of the summit access road.
- Install “No Parking” signs adjacent to the path leading to the lodge area. It is very difficult for visitors to back out of parking spaces when others are parked behind them in this area.

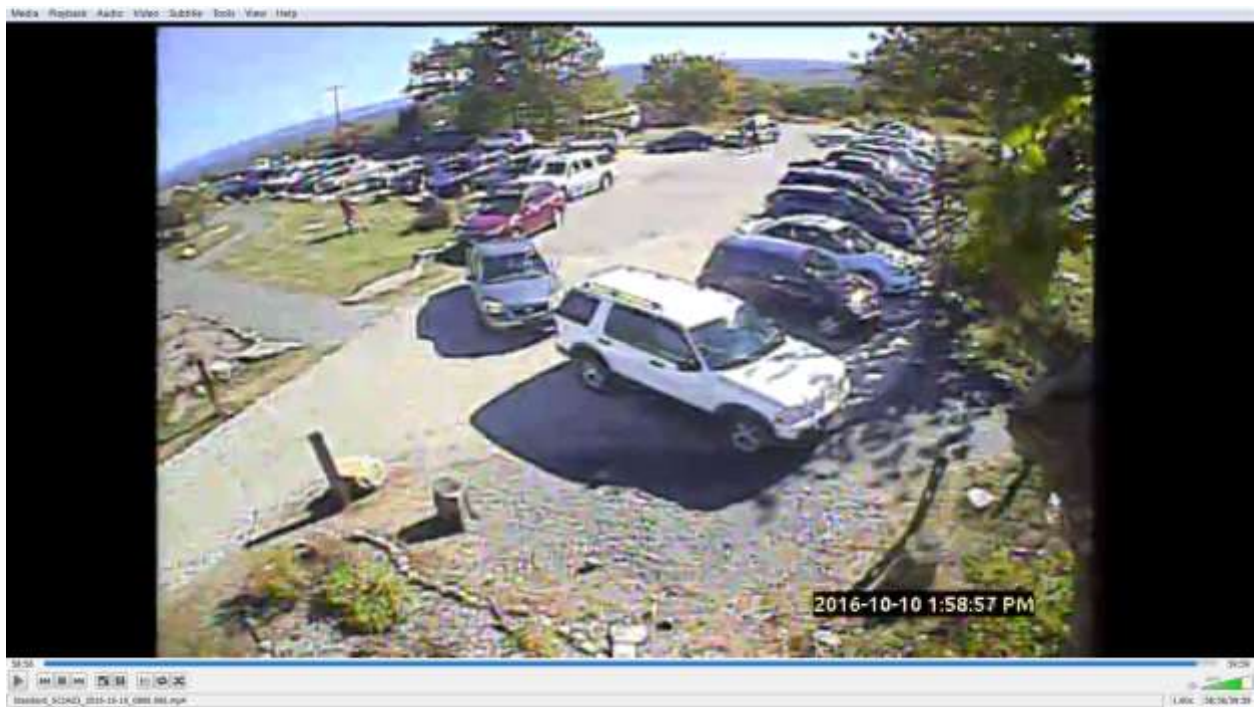
The constraints of the current lot design results in some people continuing to the end of the parking area, and then they have a very difficult time turning around. This occurs even when the overflow parking area is open, as it was in the early afternoon of Columbus Day:

- Provide additional space at the east end of the main parking area for vehicles to turn around. This would help with the current problem when visitors have to back out of the parking area if they cannot find an available space

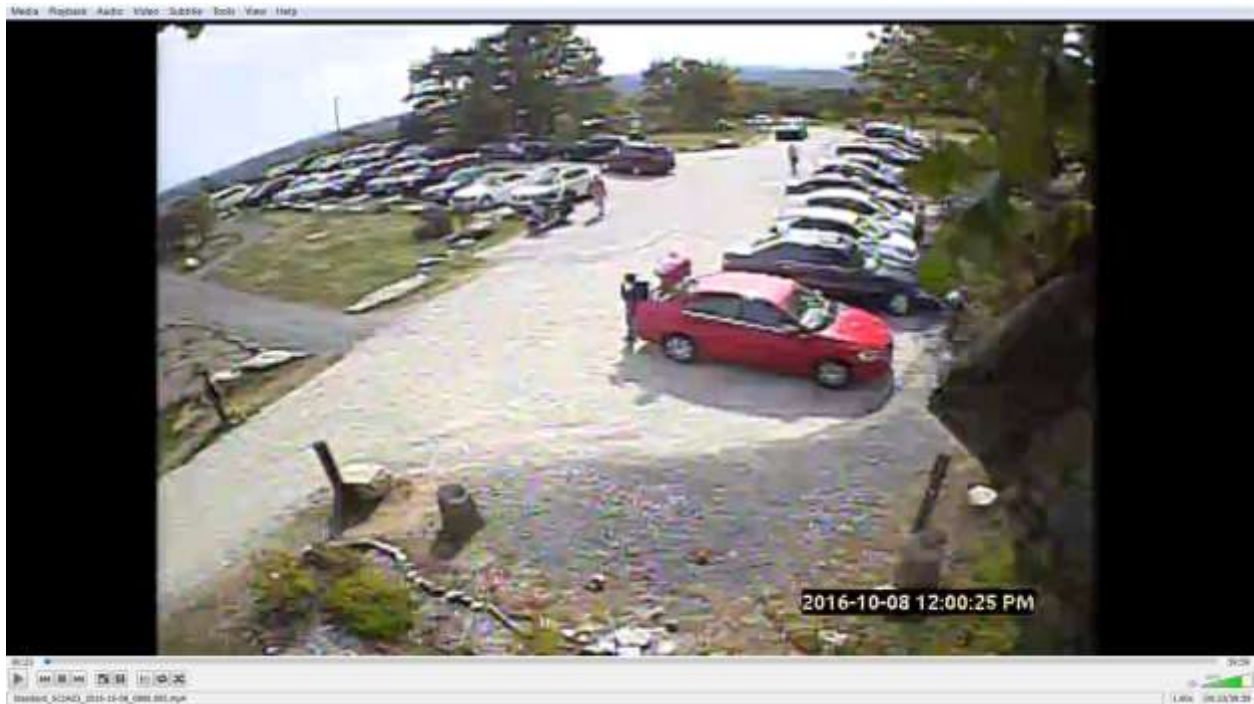
The other situation that occurs is that people are forced to back out of the parking area after not being able to find a spot, and conflict with other drivers entering the area from the access road, as the maroon van is attempting in the photo below:

- Consider creating a one-way loop between the main parking area and the overflow parking lot. This would allow for better traffic flow, particularly during busy times when drivers frequently have to back up through the parking area when no parking spots are available. There is currently a gravel access road in place for maintenance vehicles connecting the two areas.

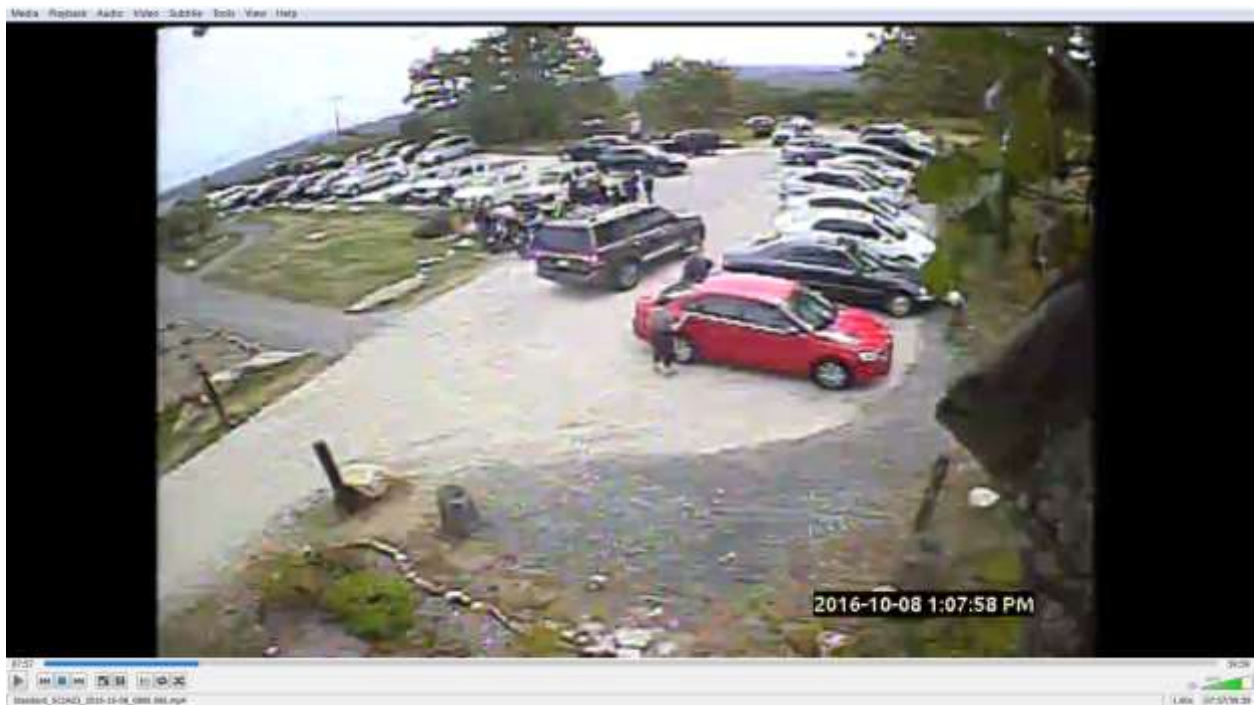
Another result of the confined space is conflicts between multiple vehicle movements at the same time. In the photo below, several cars are entering via the access road while two vehicles are attempting to leave, and another vehicle is backing out of a space.

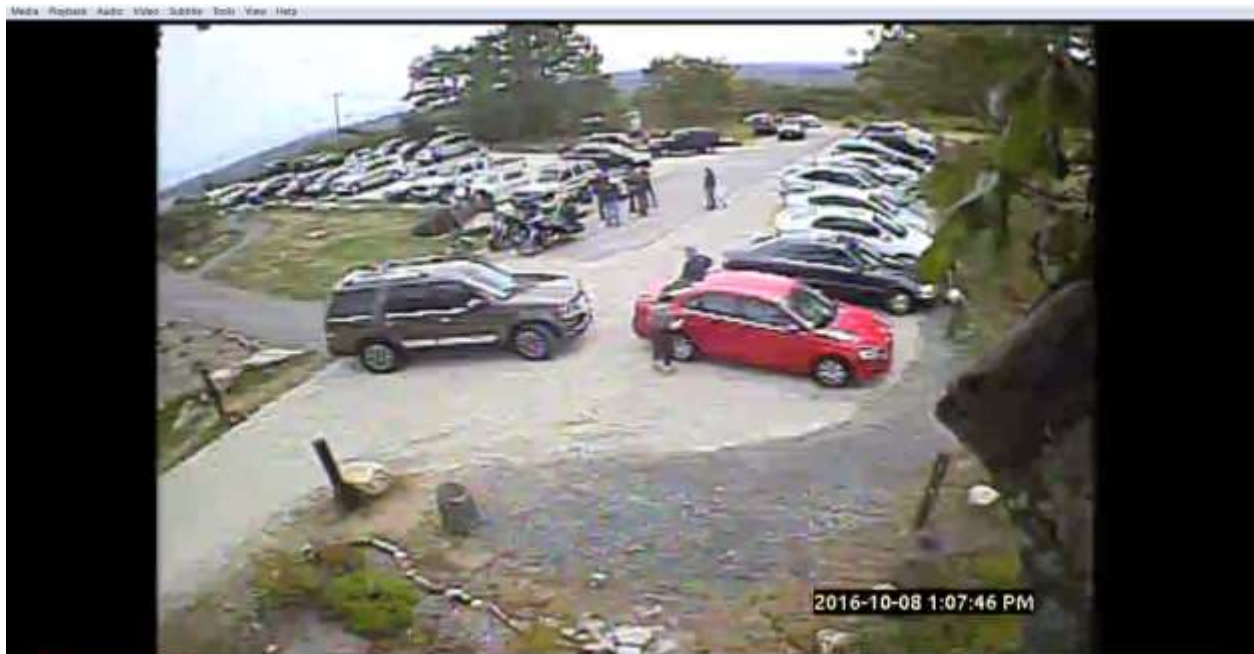
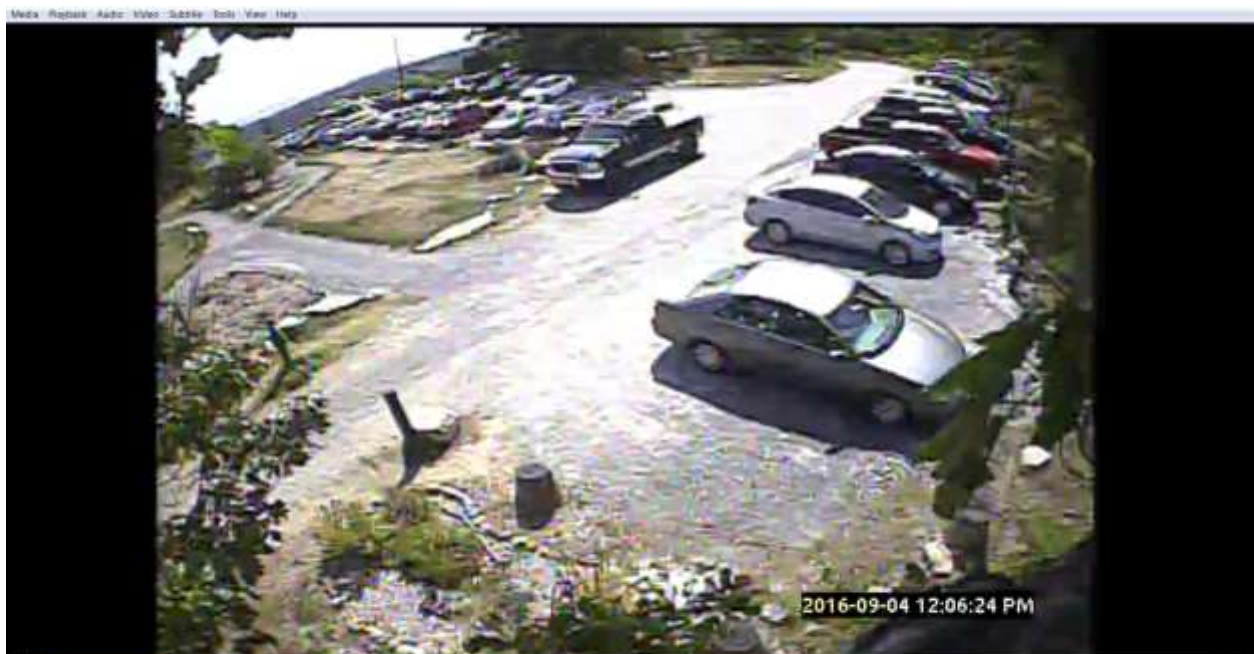
Many of the spaces on the west side of the lot do not provide the proper distance for backing, especially for larger vehicles. Below is an example of a larger vehicle attempting to back out of the space and maneuver to leave. This situation is made more difficult when people park along the side of the lot, directly behind the other vehicles – such as the motorcycles below or the black pickup truck in the photos below.

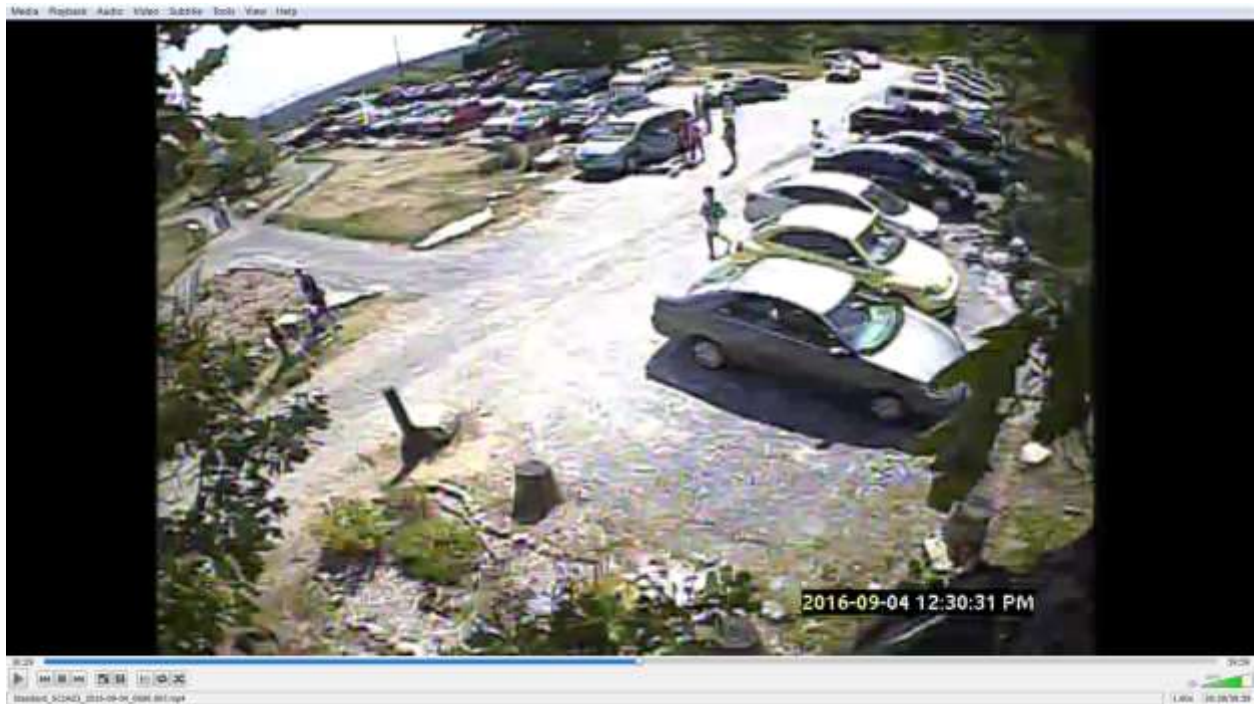
Since there is no way for people to know whether spaces are available, drivers queue up near the top of the access road. Below is a good example, where several vehicles are entering the parking lot area, but both areas are already full.

- If paving is not considered, pursue other options for guiding visitors to park more efficiently. These could include additional signage or flexible guides/poles.

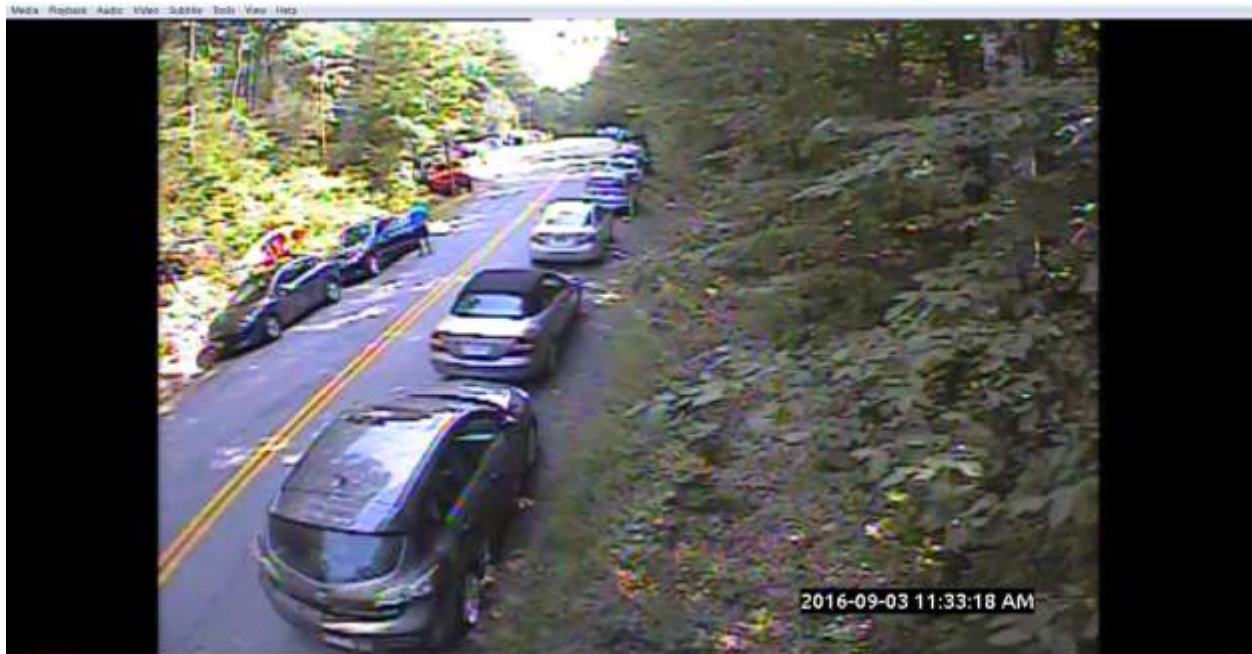
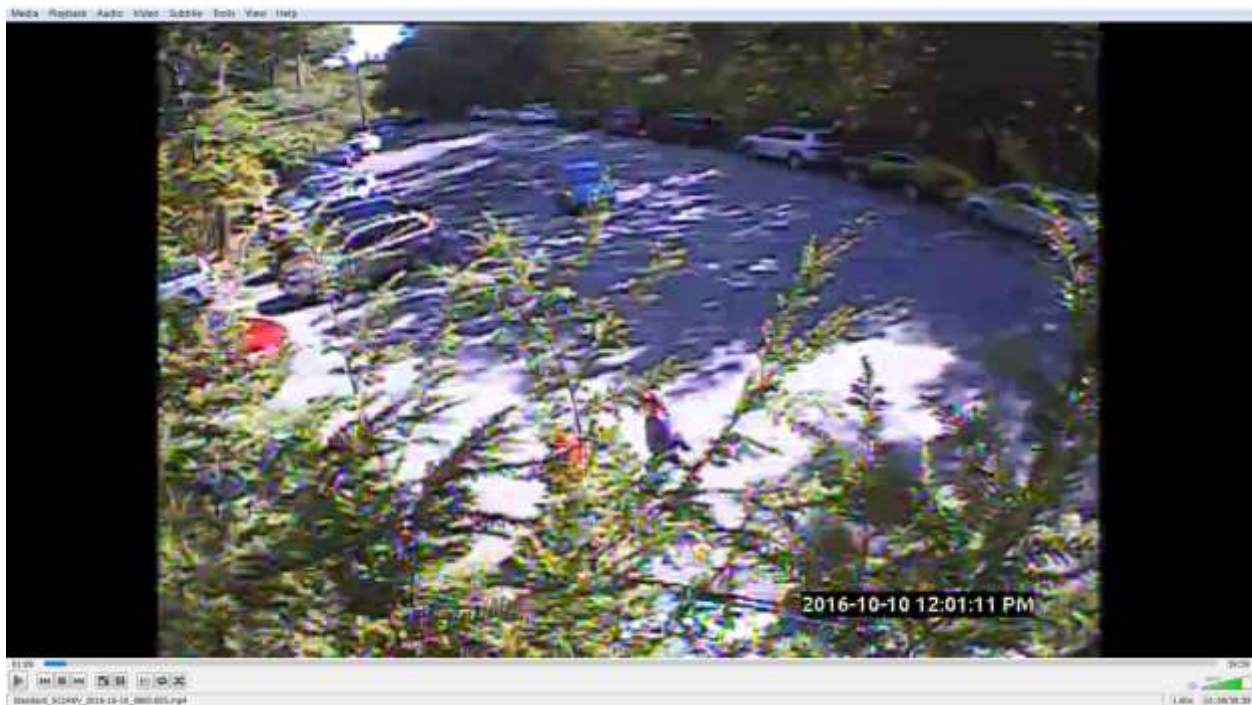
There are approximately 12-15 spaces at the base parking area, depending on the size of vehicles and how close together people park. There are a lot of people who come to Mt. Agamenticus to hike from the base to the summit, so demand is high. The result is that at busy times during weekday and weekend days, people park along both sides of Mountain Road. Examples are shown in the photos that follow.

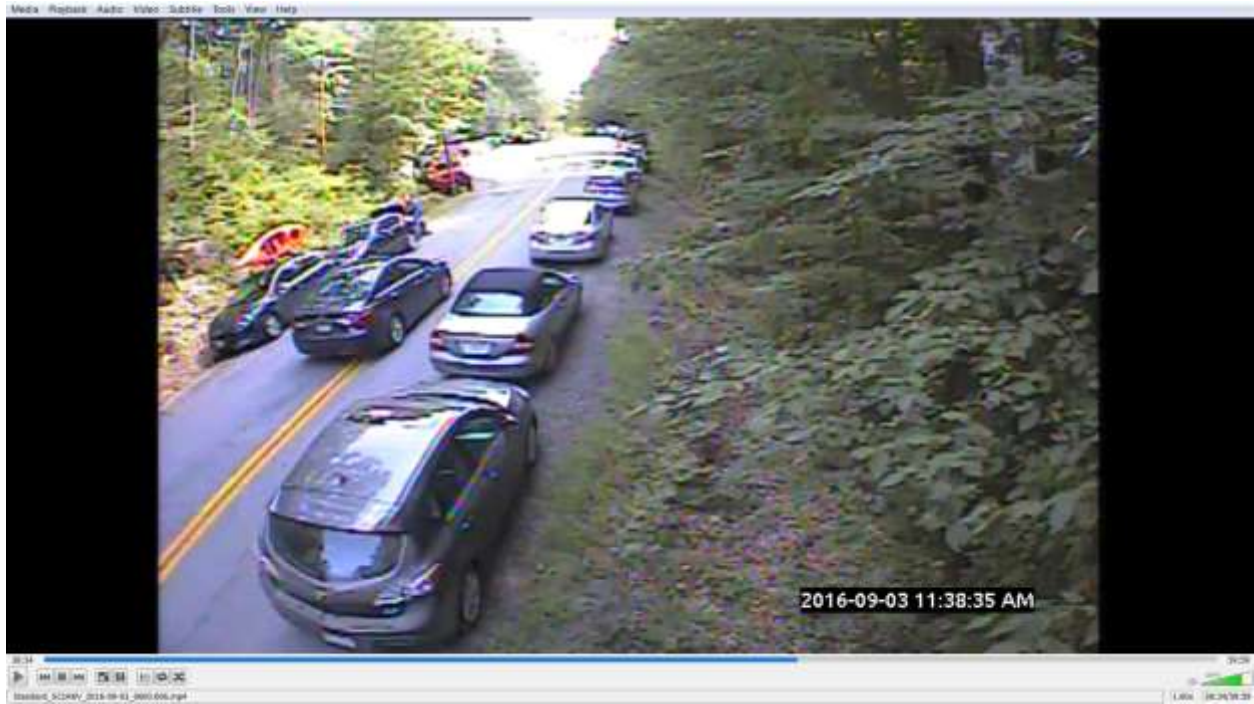
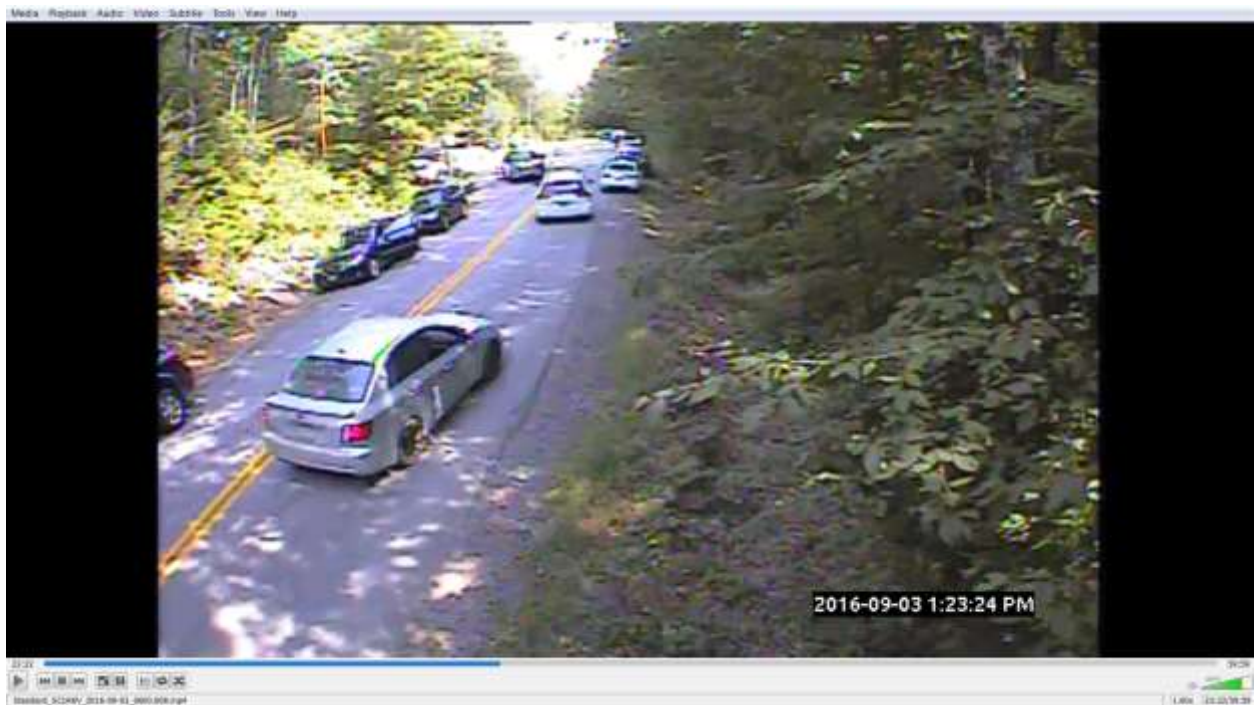
The most obvious result of the parking situation on Mountain Road is that the available travel way can only accommodate one vehicle at a time, as seen below:

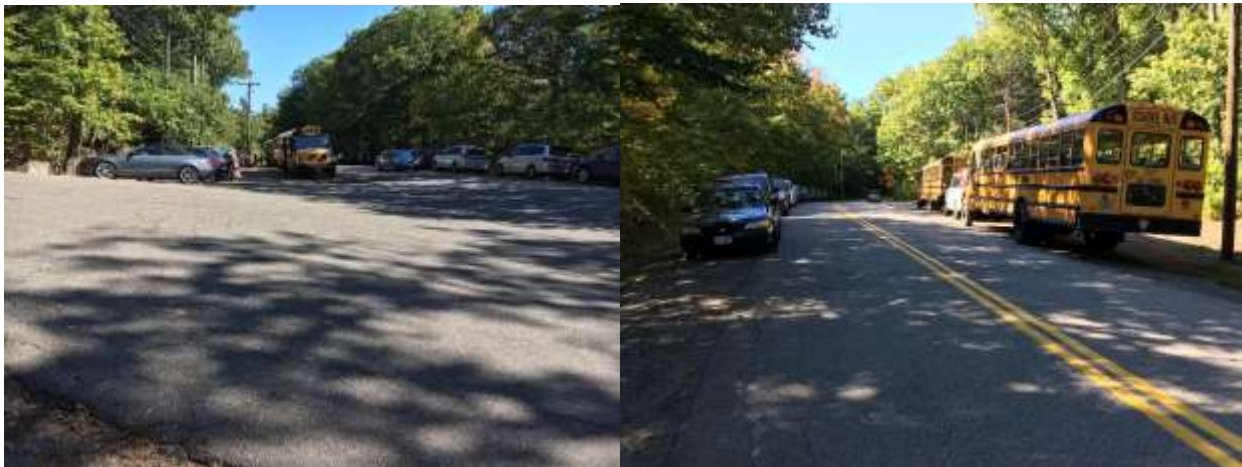
School Groups Loading at Base Parking Area

During the week, several school groups often visit the mountain. Some of the buses park in the overflow parking area at the summit, but many buses also park along Mountain Road at the base while waiting for students. When it is time to load, buses typically pull up behind parked vehicles at the base parking lot to pick up student groups. The amount of space available at the base area for large vehicles to park and maneuver is very limited.

Groups of younger children are generally kept well organized while they are waiting to get on their bus. However, staff observed older students wandering around the base parking area and along Mountain Road. On one day, there was a small touch football game occurring in the roadway.

Also, due to the fact that the buses prefer to load students from the area behind parked cars, many need to turn around using the access road entrance. The following photos show the Mountain Road parking situation on a busy Friday, with several school groups visiting Mt. Agamenticus.
